Home Inspection Report

Prepared for: Commercial Sample

Prepared by: Habitec Inspections, LLC
PO Box 413
Brentwood, Tennessee 37024

Commercial Sample 2019.inspx
Report copywrite 2006-2017, Habitec Building and Home Inspections LLC

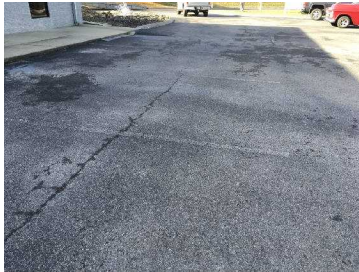
Structure Shape and Estimated Dimensions: 12,000 Square Feet nominal Rectangular Building
Parking Lot Surface: Asphalt - **HABITEC recommends repairing cracks to prevent water intrusion.**

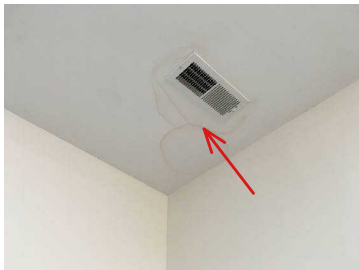
17. Functional Ceiling: Painted Drywall - Moisture Penetration noted in most of the offices. The office with a ceiling fan has a prior moisture penetration around the HVAC vent which was also observed in the closet.

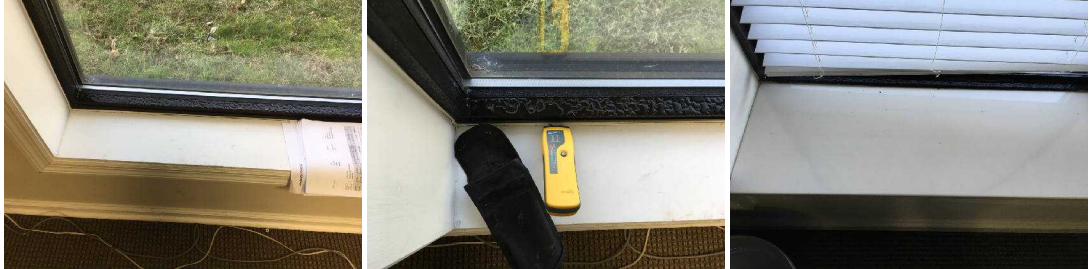
23. Functional Windows: Aluminum Fixed Pane - All Office exterior windows have active condensation. Window frame is measuring for active moisture penetration.

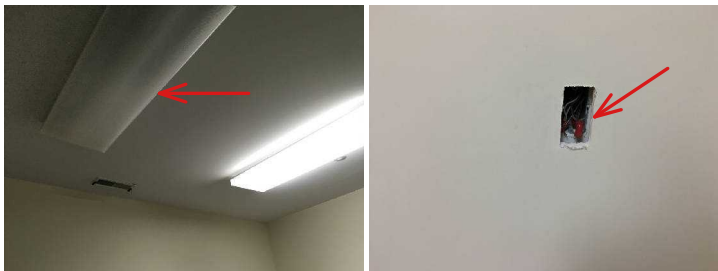
24. Functional Electrical: 120 VAC outlets and lighting circuits - Copier room office has an inoperable light. Note missing junction box ex-conference room.

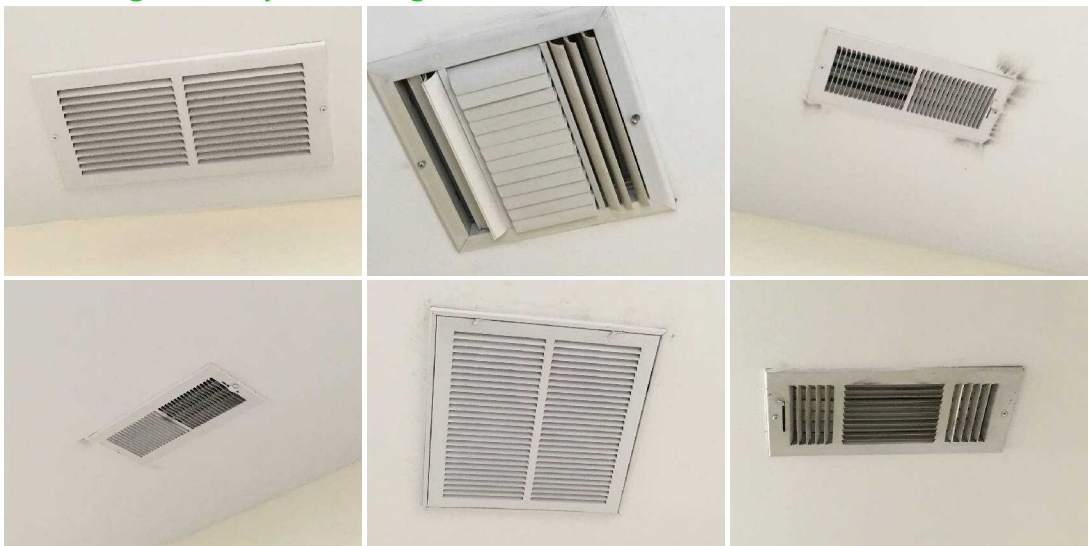
25. Acceptable Emergency Lighting: Operational
26. Functional HVAC Source: Forced-air System Register (s) - Most offices and break area have active microbial growth.
Conference Room has active microbial growth.
Accounting has heavy microbial growth.

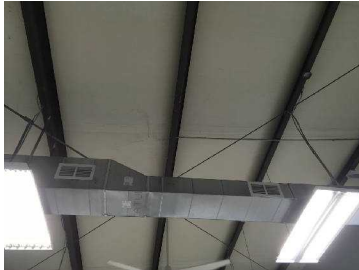
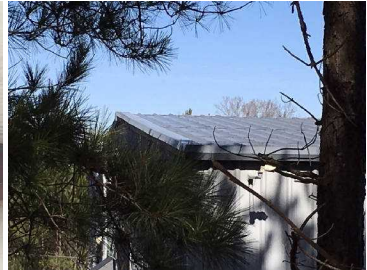
1. Functional Ceiling: Exposed framing - **Photo 2 Note Patch Repair. Photo 3 is a exterior view of the roof in this area.**

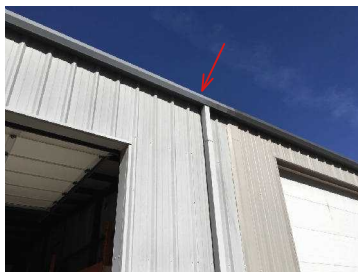
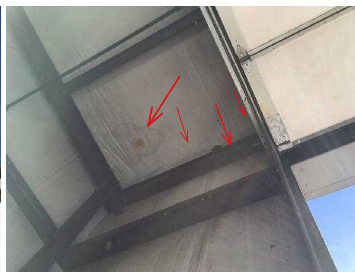
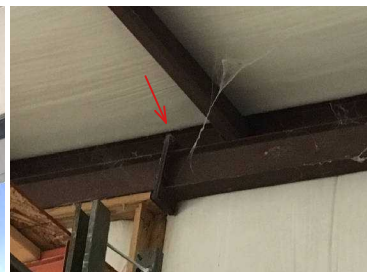
1. Functional Ceiling: Exposed framing - **Note moisture penetration in Photo 2. Photo 3 is the back outside wall of the warehouse.**

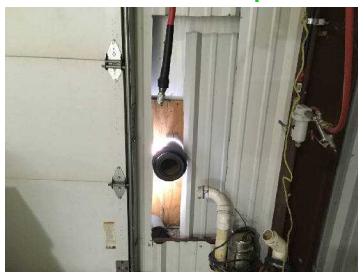
3. Functional Walls: Metal - **Wall penetration to be removed and sealed.**

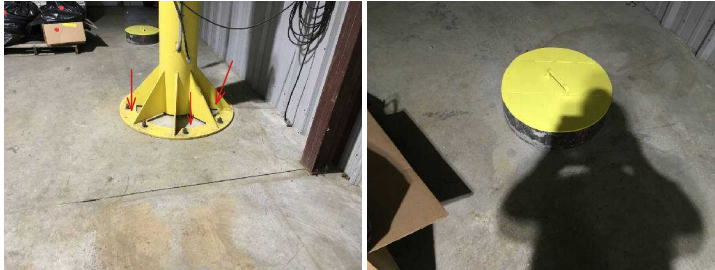
4. Functional Floor: Poured Concrete - Jib crane is being removed and the bolts are to be ground down and poly sealed to prevent a tripping hazard.
Photo 2. Well access is going to be removed.

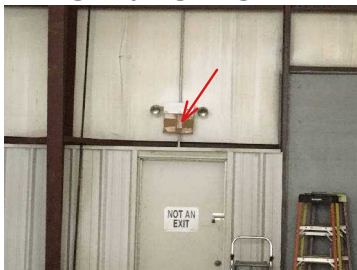
6. Acceptable Electrical: 120-208-240 VAC outlets and lighting circuits
7. Not Inspected Emergency Lighting: Not Inspected - Note Cardboard Cover

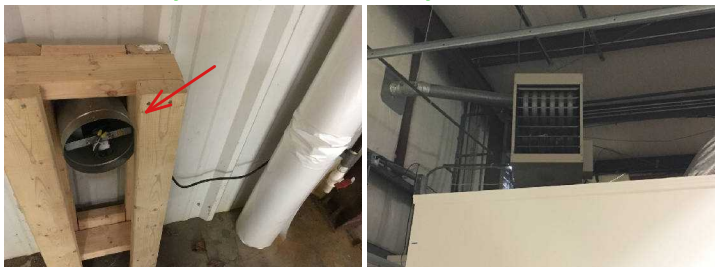
8. Functional HVAC Source: Forced-air System Register (s), Gas powered Industrial Heater - Note power vent.
Recommend you inquire as to why this unit was installed.

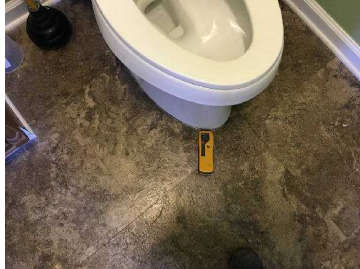
Toilets: White Porcelain, Two Piece, Gravity Flow - Toilet is testing for an active leak.

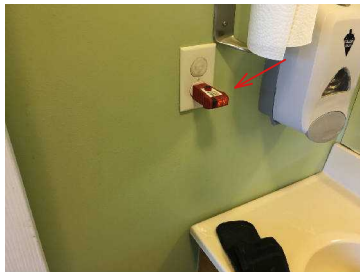
Electrical: 120 VAC outlets and lighting circuits - The outlet at the sink did not trip when interrogated with a GFCI outlet tester. HABITEC recommends a GFCI protected circuit or outlet be installed.

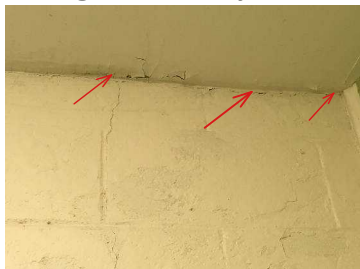
Ceiling: Painted Drywall - Ceiling is showing signs of moisture penetration.

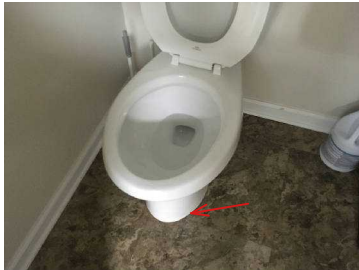
31. Marginal Toilets: White Porcelain, Two Piece, Gravity Flow - Toilet is testing for an active leak.

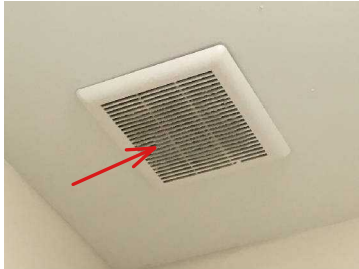
33. Functional Ventilation: Electric ventilation fan - Unit needs cleaning.

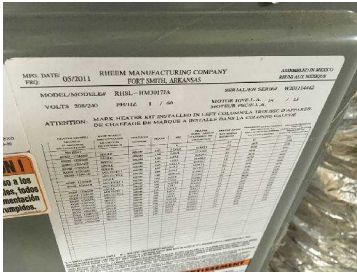
1. Area Served: Rear Offices Approximate Age: 2011
2. Functional Heating System Operation: Inadequate - Humidity in the area where this unit was operating was measure at a level conducive to microbial growth. Recommend service by a qualified HVAC technician.
3. Manufacturer: Rheem

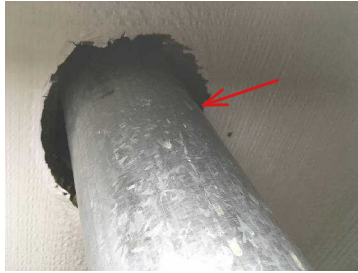
50. Acceptable Draft Control: Automatic
51. Marginal Flue Pipe: Double wall - Class B piping requires a 1" clearance from all combustibles. This is a fire hazard.
The arrow identifies the location of an active water leak.

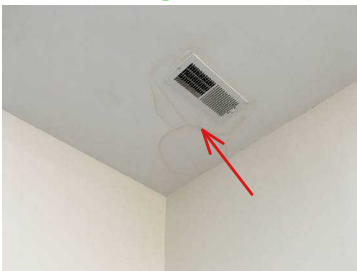
2. Office (s) Living Space Ceiling: Painted Drywall - **Moisture Penetration noted in most of the offices. The office with a ceiling fan has a prior moisture penetration around the HVAC vent which was also observed in the closet.**

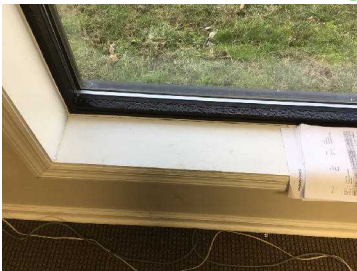
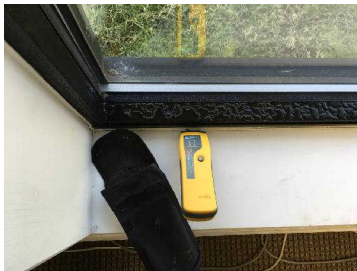
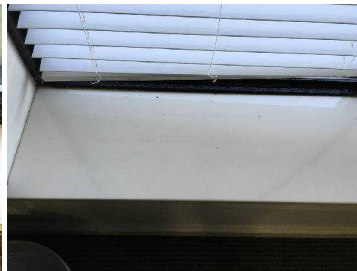
3. Office (s) Living Space Windows: Aluminum Fixed Pane - **All Office exterior windows have active condensation. Window frame is measuring for active moisture penetration.**

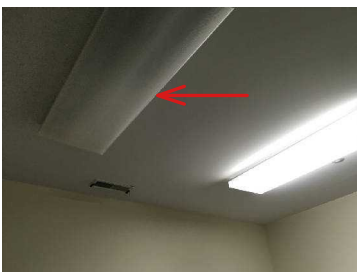
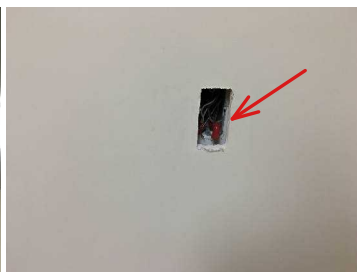
4. Office (s) Living Space Electrical: 120 VAC outlets and lighting circuits - **Copier room office has an inoperable light.**
Note missing junction box ex-conference room.

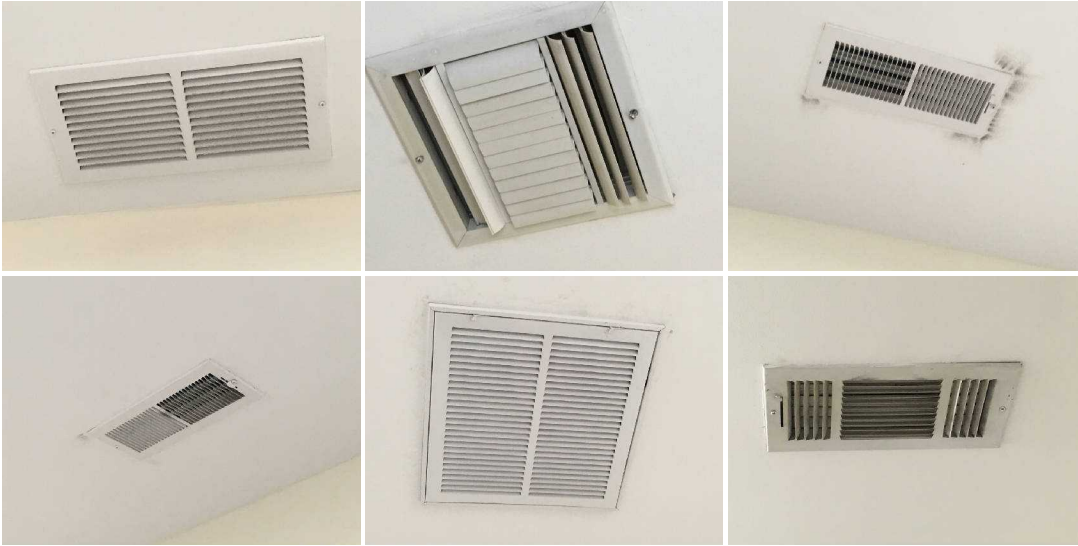
5. Office (s) Living Space HVAC Source: Forced-air System Register (s) - **Most offices and break area have active microbial growth.**
Conference Room has active microbial growth.
Accounting has heavy microbial growth.

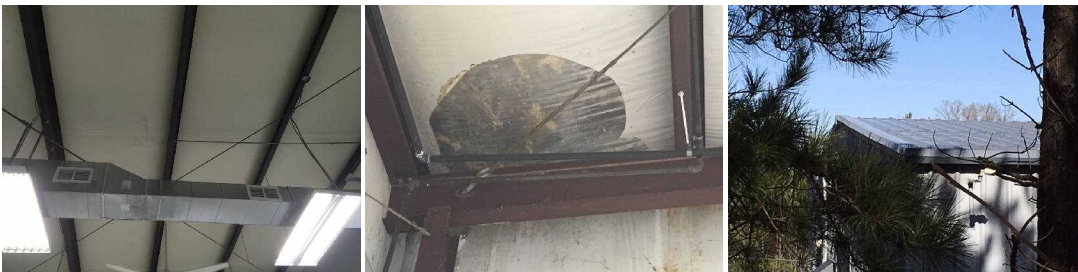
6. Machine Shop Work Area Ceiling: Exposed framing - **Photo 2 Note Patch Repair. Photo 3 is a exterior view of the roof in this area.**

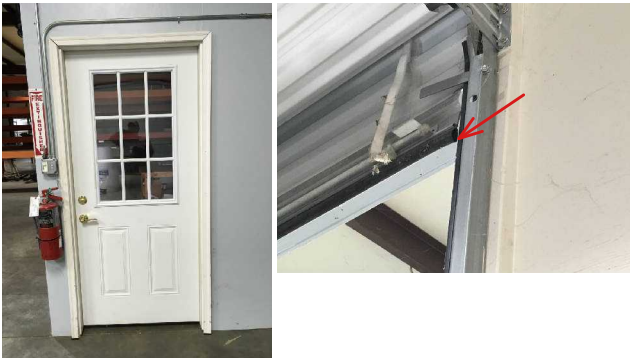
7. Machine Shop Work Area Doors: Exterior Composite, Overhead Door - **Overhead door track guide is missing.**

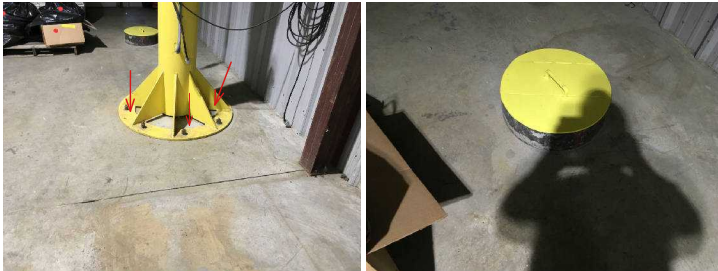
10. Warehouse Work Area Floor: Poured Concrete - Jib crane is being removed and the bolts are to be ground down and poly sealed to prevent a tripping hazard.

Photo 2. Well access is going to be removed.

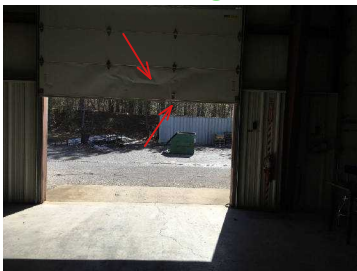
11. Warehouse Work Area Doors: Overhead Insulated Aluminum - Southeast Door is damaged. Several of the doors have damaged seals which may allow pest intrusion.

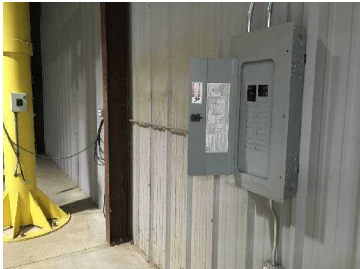
23. Sub-Panel #2 Electric Panel Manufacturer: Eaton - Panel is missing four screws.

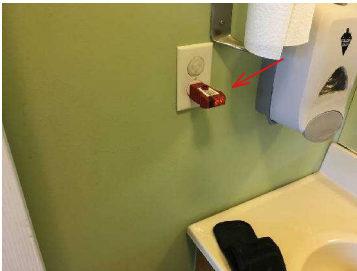
3. Women Half Bathroom Electrical: 120 VAC outlets and lighting circuits - **The outlet at the sink did not trip when interrogated with a GFCI outlet tester. HABITEC recommends a GFCI protected circuit or outlet be installed.**
