Habitec Inspections, LLC

Definitions

General Information

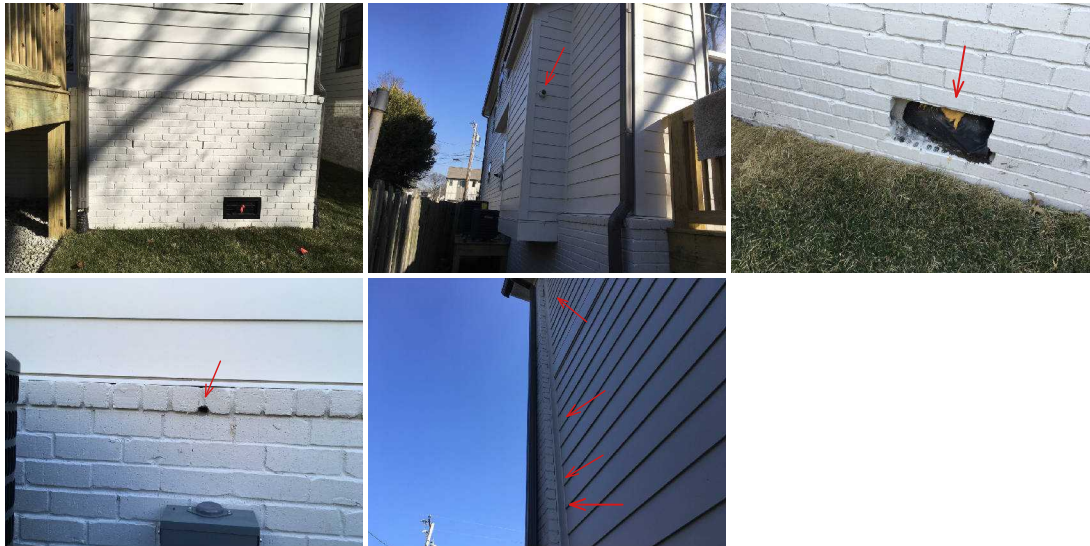
- 1. Functional** **Type: Brick Veneer -** Potential for water penetration noted in unsealed areas. Recommend sealing to prevent water intrusion.

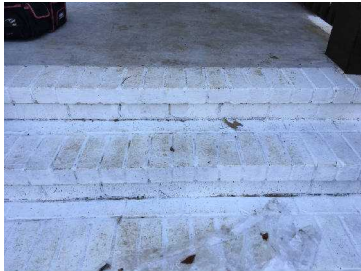
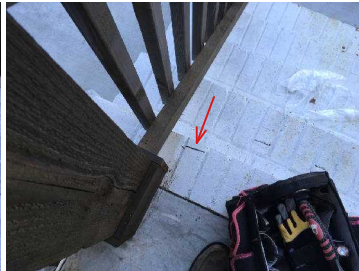
Steps/Stoops: Concrete, Brick - Note crack in brick in Photo 2. Recommend Repair.

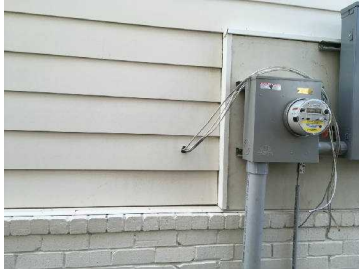
18. Not Inspected Cable TV Junction Boxes: None Observed - Note-penetration hole is not sealed.

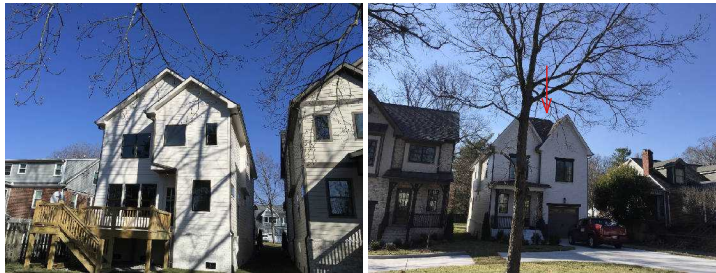
1. Method of Inspection: Ground level
2. Not Inspected Unable to Inspect: 75% - Unable to Inspect completely due to the height and slope of the roof.

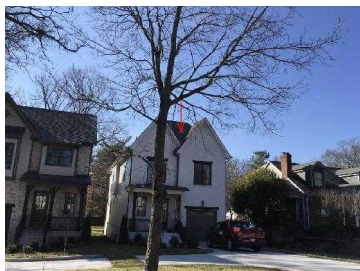
10. Functional Valleys: Composite Shingle - The gutter system servicing this area of the home does not appear to be sufficient to handle the volume of water coming from the roof. Recommend confirmation that this has been considered and is sufficient.

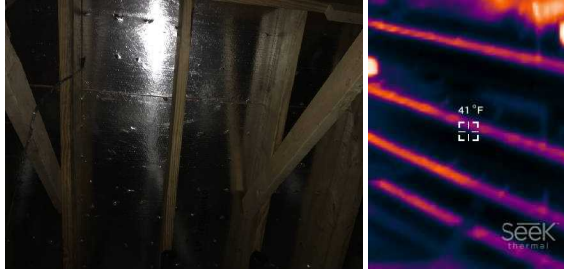
5. Not Inspected Sheathing: None Observed - Sheathing is blocked from view by aluminum based backing. This backing is an excellent feature for a home. Infrared view does not indicate any penetrations.

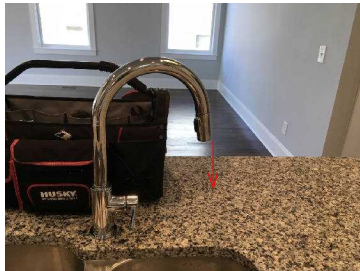
Faucets/Fixtures: Single Handle with Spray Head - **Faucet is not equipped with a stop. Recommend repair.**

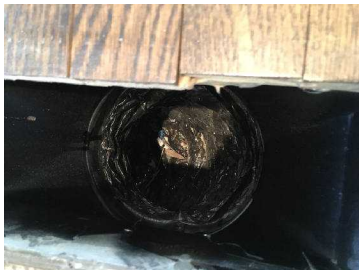
22. Acceptable Windows: Composite Fixed Pane
23. Acceptable Electrical: 120 VAC outlets and lighting circuits, 120 VAC GFCI
24. Not Present Smoke Detector: None Observed
25. Functional HVAC Source: HVAC System Register-Floor Mount - Significant debris was observed in the supply duct(s) below the register(s). Photo is representative. Recommend cleaning.

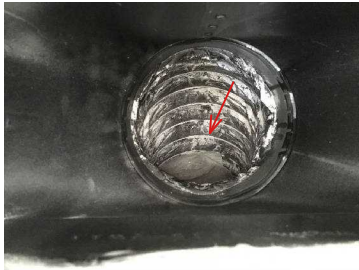
18. Functional HVAC Source: HVAC System Register-Floor Mount - Significant debris was observed in the supply duct(s) below the register(s). Photo is representative. Recommend cleaning.

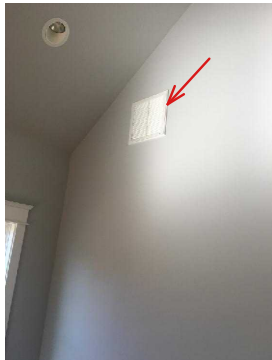
- 8. Acceptable Electrical: 120 VAC outlets and lighting circuits
- 9. Functional HVAC Source: HVAC System Register-Ceiling Mount - **Air return is very noisy. Recommend Repair.**

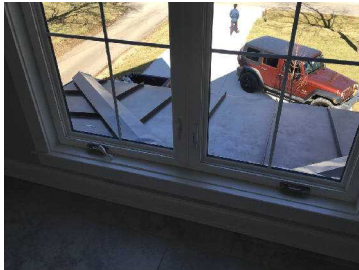
- 5. Functional Windows: Composite Casement. - **Note missing handle on right side and the white handle on the left does not match the window color.**

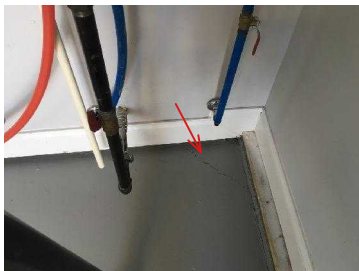
10. Functional Floor/Foundation: Concrete block - **HABITEC recommends repair to fill any crack greater than 1/4 inch in width or where significant differential elevations exist. These cracks do not appear to exceed this dimension.**

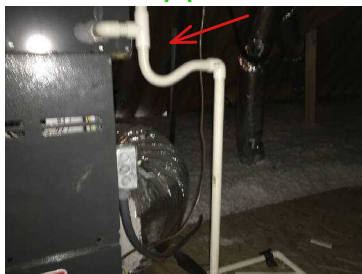
14. Functional Condensate Removal: PVC - The air handler is in the attic to provide heat for the second floor and handle air from the compressor unit outside. HABITEC recommends insulation of the first 10 feet of this drain pipe.

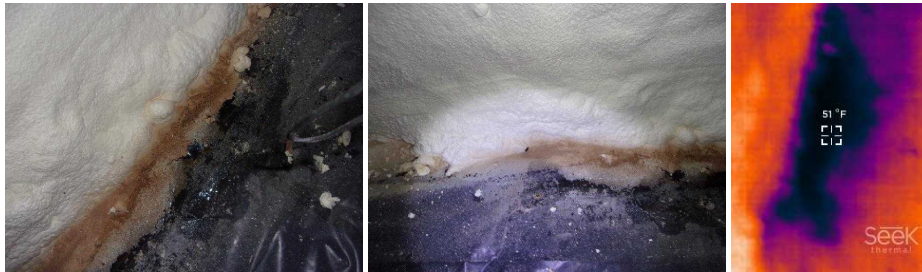
1. Method of Inspection: In the crawl space
2. Not Inspected Unable to Inspect: 30% - Complete access blocked by HVAC ductwork or limited access.
3. Acceptable Access: Metal Door
4. Acceptable Access Point: Exterior of the House
5. Marginal Moisture Penetration: Evidence of Active Moisture Penetration - **Northwest corner of the crawl space has active moisture penetration. Infrared analysis suggests the area is approximately 30" in length. Recommend Repair.**

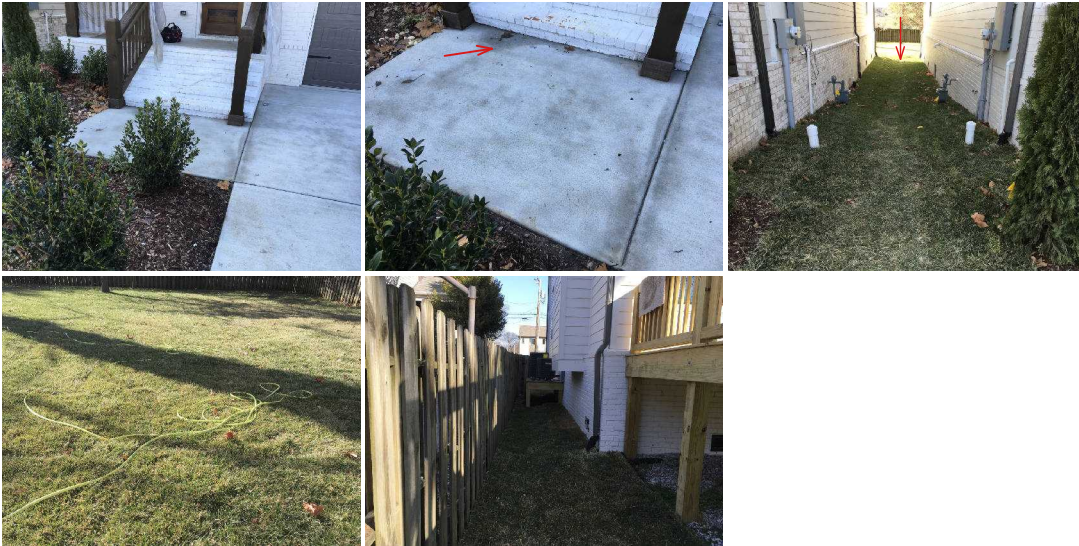
1. **Grading:** Moderate slope, Flat, Negative slope - The grading and driveway is directing water to the base of the first step at the front of the home. Recommend Repair (Photo 2). Water is collecting between the two homes and does not appear to have sufficient drainage (Photo 3).

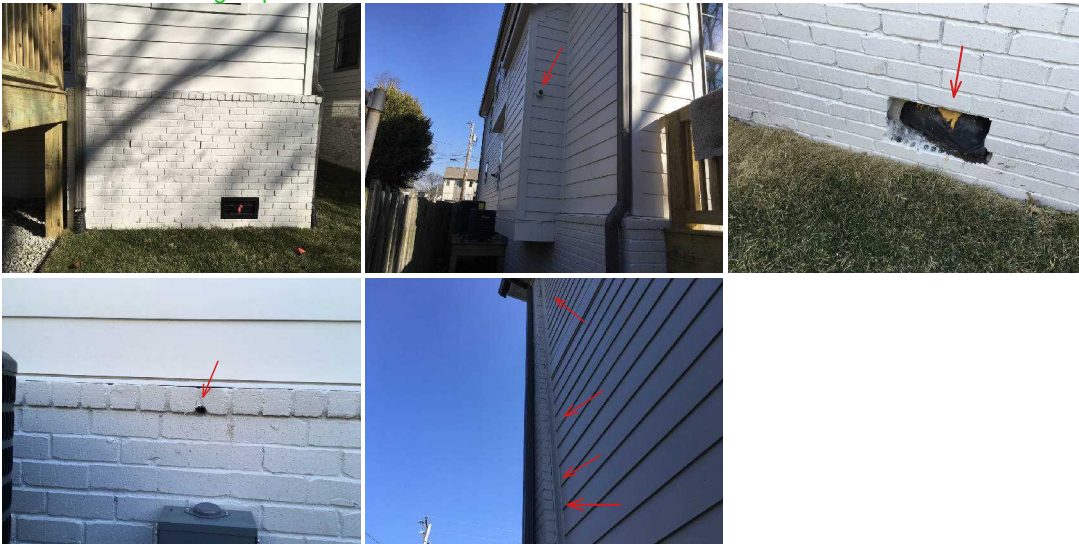
2. **1st Floor Exterior Surface.** Exterior Surface Type: Brick Veneer - Potential for water penetration noted in unsealed areas. Recommend sealing to prevent water intrusion.

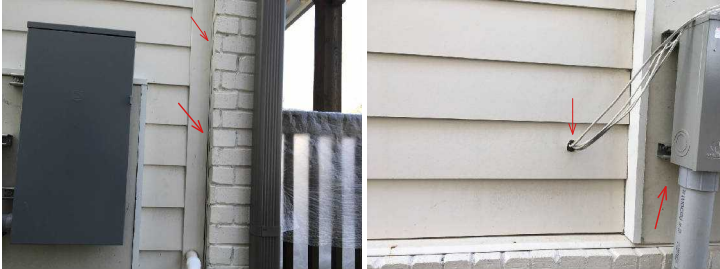
3. **2nd Floor Exterior Surface** Exterior Surface Type: Composite Siding - Several cut outs not sealed and along mating surfaces. The surface behind the electrical panels does not appear to be treated. Recommend Repair.

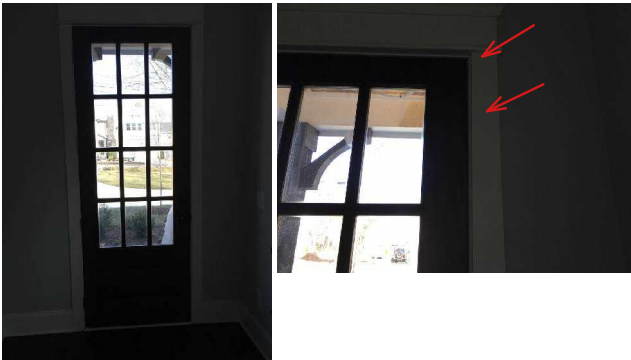
5. Entry Doors: Front Door, Framed Glass, Wood - Note gap in upper right hand corner.

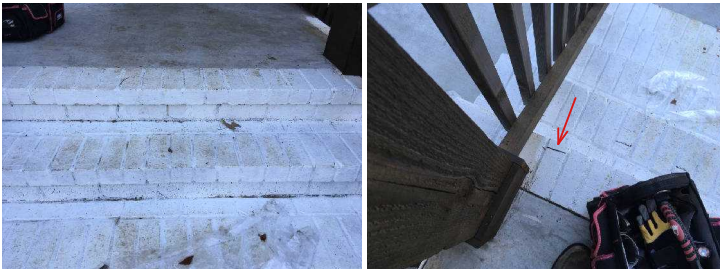
6. Steps/Stoops: Concrete, Brick - Note crack in brick in Photo 2. Recommend Repair.

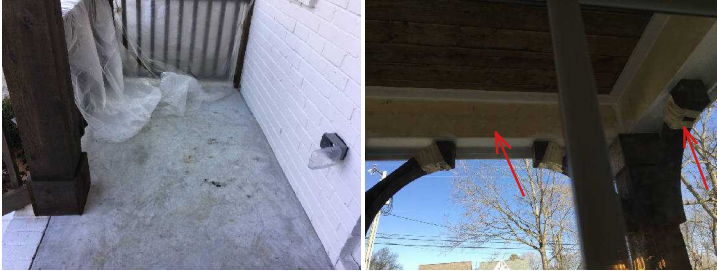
7. Porch: Concrete, Covered - Roof is not Finished.

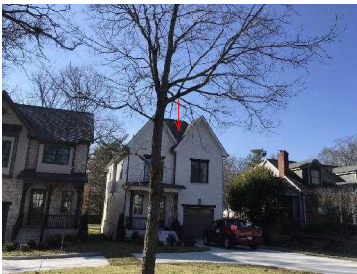
8. Valleys: Composite Shingle - The gutter system servicing this area of the home does not appear to be sufficient to handle the volume of water coming from the roof. Recommend confirmation that this has been considered and is sufficient.

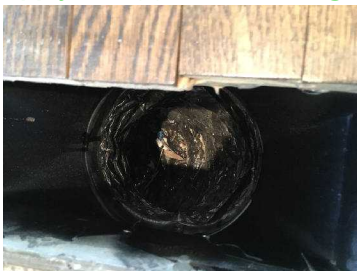
10. 1st Floor Kitchen HVAC Source: HVAC System Register-Floor Mount - Significant debris was observed in the supply duct(s) below the register(s). Photo is representative. Recommend cleaning.

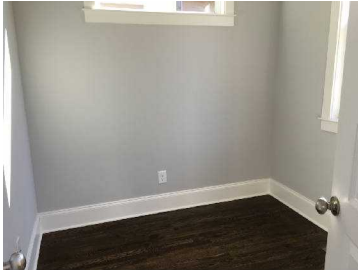
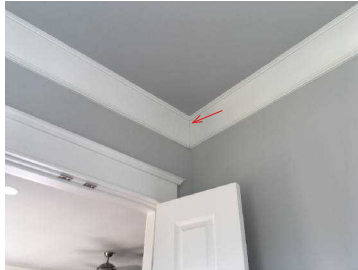
12. 1st Floor Office Living Space Walls: Painted Drywall - **Miter joints are not sealed.**

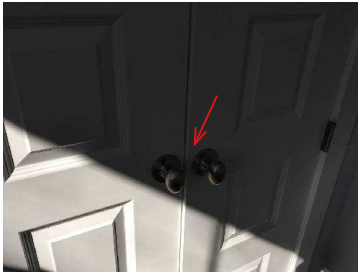
13. 1st Floor Office Living Space Doors: Double Doors - **Door does not close properly. Recommend Repair.**

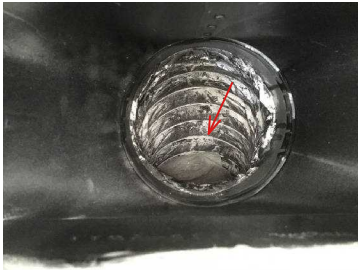
14. 1st Floor Office Living Space HVAC Source: HVAC System Register-Floor Mount - **Significant debris was observed in the supply duct(s) below the register(s). Photo is representative. Recommend cleaning.**
