Home Inspection Report

Prepared for: Commercial Sample

Prepared by: Habitec Inspections, LLC
PO Box 413
Brentwood, Tennessee 37024

Commercial Sample 2019.inspx
Report copywrite 2006-2017, Habitec Building and Home Inspections LLC

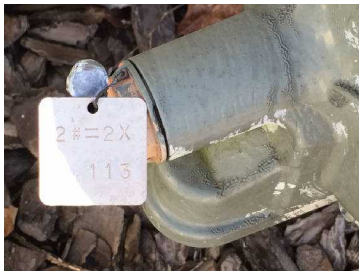
10. Acceptable Gas Meter: Exterior Surface Mount - Note that this meter is for 2#s Gas Pressure. Any gas based systems should be confirmed for this system.

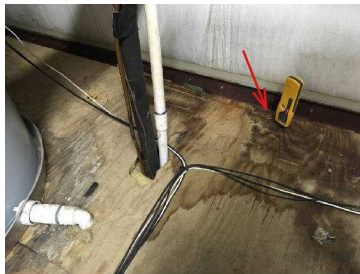
- 1. Acceptable Ceiling: Exposed framing
- 2. Acceptable Ceiling Height (Estimated): Less Than 7FT
- 3. Acceptable Walls: Exposed framing
- 4. Marginal Floor: Wood - **There is an active water penetration near the hot water heater at the point where a PVC pipe exits the wall.**

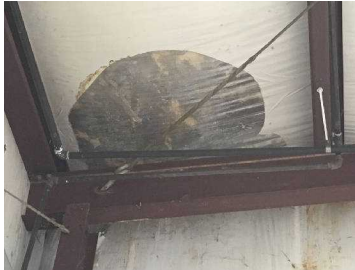
1. Functional Ceiling: Exposed framing - **Photo 2 Note Patch Repair. Photo 3 is a exterior view of the roof in this area.**

6. Machine Shop Work Area Ceiling: Exposed framing - **Photo 2 Note Patch Repair. Photo 3 is a exterior view of the roof in this area.**

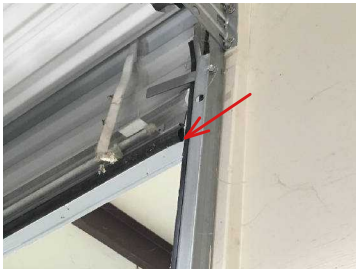
5. Functional Doors: Exterior Composite, Overhead Door - **Overhead door track guide is missing.**

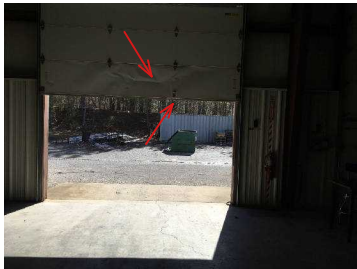
5. Functional Doors: Overhead Insulated Aluminum - Southeast Door is damaged. Several of the doors have damaged seals which may allow pest intrusion.

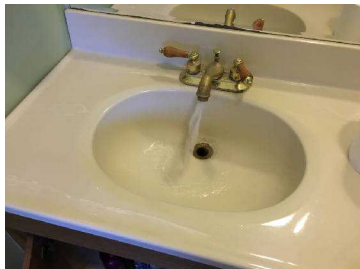
- 6. Acceptable Sink/Basin: Molded single bowl, No Overflow Protection
- 7. Functional Faucets/Fixtures: Dual Handle - Sink has no stop

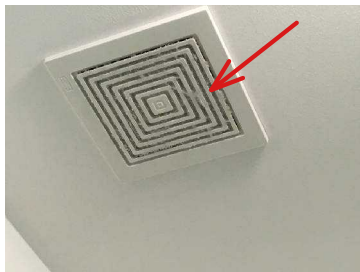
Ventilation: Electric ventilation fan - Unit is very dirty.

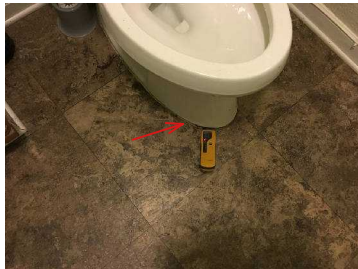
21. Marginal Toilets: White Porcelain, Two Piece, Gravity Flow - Toilet is testing for an active leak.

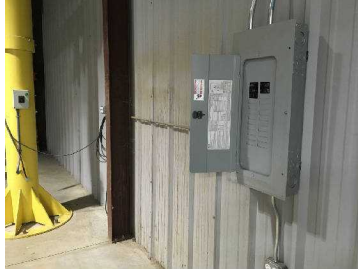
39. Functional Manufacturer: Eaton - **Panel is missing four screws.**

23. Sub-Panel #2 Electric Panel Manufacturer: Eaton - Panel is missing four screws.

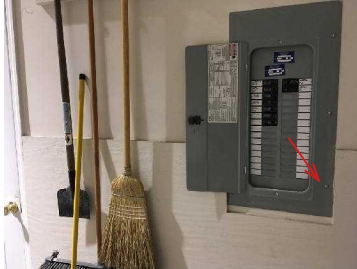
50. Functional Manufacturer: Eaton - **Mounting screw missing.**

24. Warehouse Electric Panel Manufacturer: Eaton - Mounting screw missing.

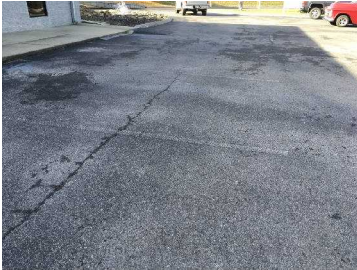
1. Parking Lot Surface: Asphalt - **HABITEC recommends repairing cracks to prevent water intrusion.**

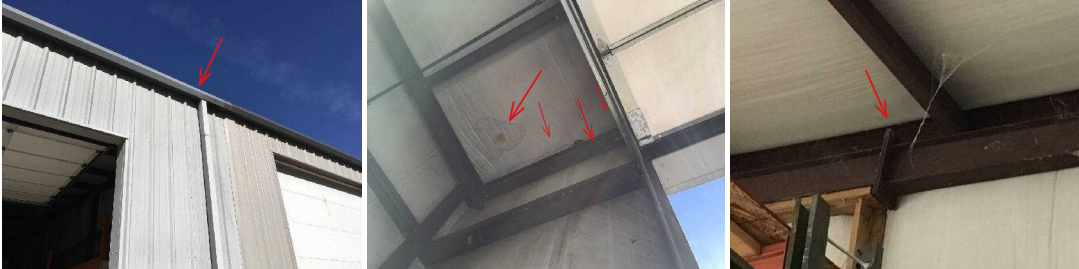
1. Functional Ceiling: Exposed framing - **Note moisture penetration in Photo 2. Photo 3 is the back outside wall of the warehouse.**

8. Warehouse Work Area Ceiling: Exposed framing - **Note moisture penetration in Photo 2. Photo 3 is the back outside wall of the warehouse.**

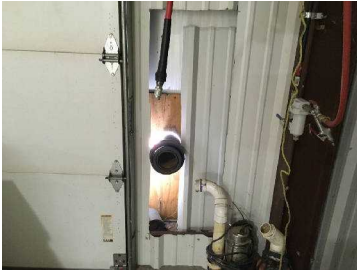
9. Warehouse Work Area Walls: Metal - Wall penetration to be removed and sealed.

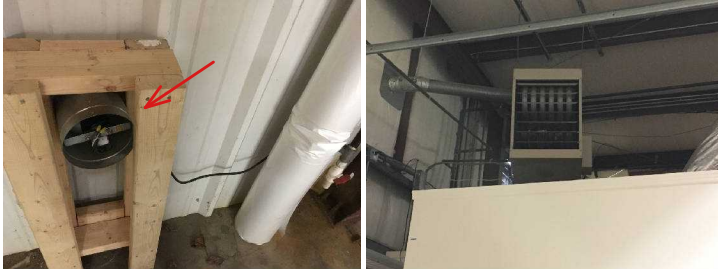
12. Warehouse Work Area HVAC Source: Forced-air System Register (s), Gas powered Industrial Heater - Note power vent. Recommend you inquire as to why this unit was installed.

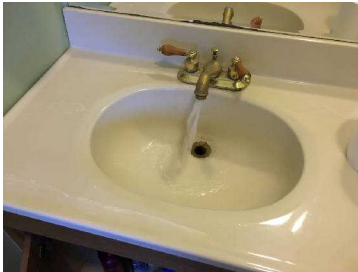
13. Women Half Bathroom Faucets/Fixtures: Dual Handle - Sink has no stop

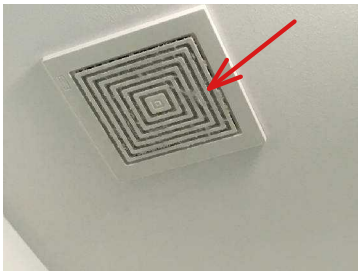
14. Women Half Bathroom Ventilation: Electric ventilation fan - Unit is very dirty.

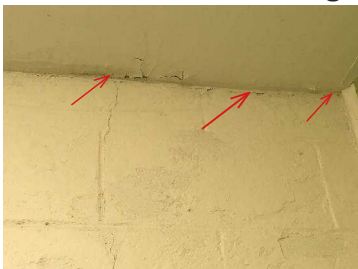
15. Men Half Bathroom Ceiling: Painted Drywall - Ceiling is showing signs of moisture penetration.

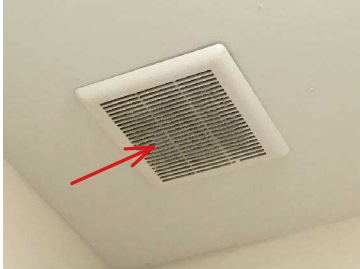
16. Kitchen Bathroom Ventilation: Electric ventilation fan - Unit needs cleaning.

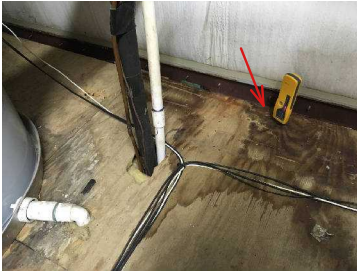
1. 2nd Floor Storage Living Space Floor: Wood - **There is an active water penetration near the hot water heater at the point where a PVC pipe exits the wall.**

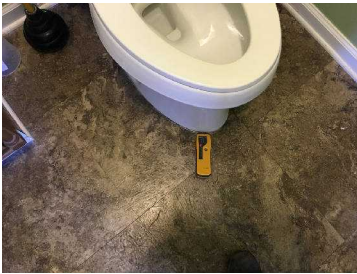
2. Women Half Bathroom Toilets: White Porcelain, Two Piece, Gravity Flow - **Toilet is testing for an active leak.**

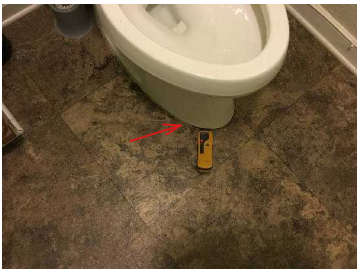
4. Men Half Bathroom Toilets: White Porcelain, Two Piece, Gravity Flow - **Toilet is testing for an active leak.**

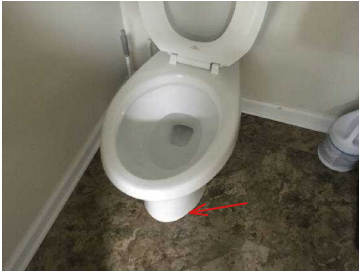
5. Men Half Bathroom Electrical: 120 VAC outlets and lighting circuits - The outlet did not trip when tested. GFCI Outlets are recommended for bathrooms.
6. Kitchen Bathroom Toilets: White Porcelain, Two Piece, Gravity Flow - Toilet is testing for an active leak.
